# Vehicle Inspection Report

## REGULAR INSPECTION ICE 4W

License Number : B 1166 PDL  
Engine Number : TZ200XSAN 4D4038777  
Model : BYD M6 Standard  
Make : BYD  
Odometer: 25405 KM  
Vehicle Status: **Maintenance Required**

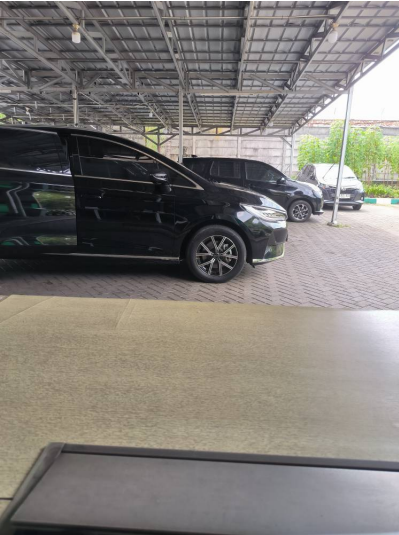
## 1. Pintu Kanan

| SN | Inspection Item | Note | Good | Repair | Replace | NA |
|---|---|---|---|---|---|---|
| 1 | Pintu Kanan | Big scratch | <input type="radio"/> | <input checked="" type="radio"/> | <input type="radio"/> | <input type="radio"/> |

Need repair
